Review Article:

In-plane Shear Strengthening of Masonry Walls after Damage

Ahmed Mohamed Raouf¹Jalal Ahmed Saeed¹¹University of Sulaimani, College of Engineering, Civil Engineering Department

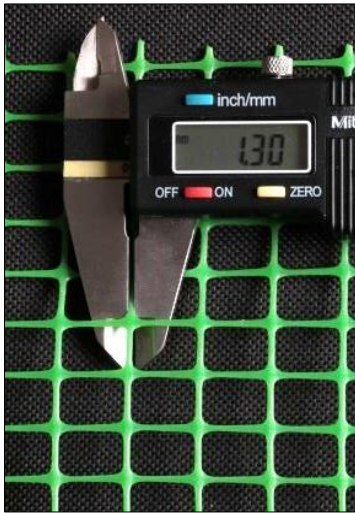
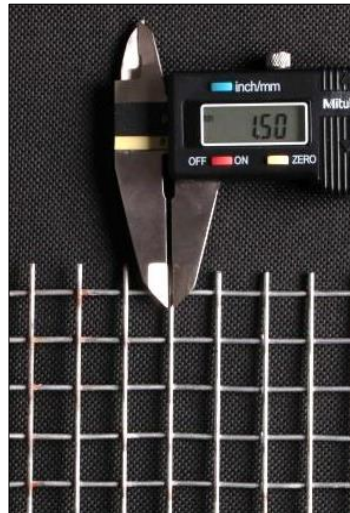
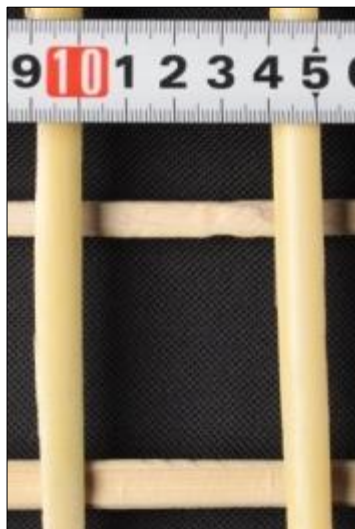
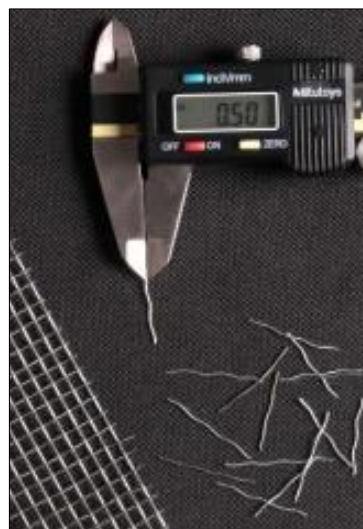
Fig.1: Strengthening materials. (Source: Researcher)

- (a) plastic mesh.
- (b) steel mesh.
- (c) glass fiber mesh.
- (d) wild cane grid.
- (e) Chopped steel fibers.

The properties of the strengthening materials such as tensile strength and weight are summarized in Table (3). Additionally, a photograph of each material is shown in Fig.1.

A polypropylene plastic mesh with a clear opening size of (13.6 × 10) mm was used. Each single wire comprising the mesh had a rectangular cross section of (1.3 × 1.1) mm as

shown in Fig.1-a. The ultimate tensile strength was 16.57 MPa based on laboratory testing of a single wire. The welded wire steel mesh had an opening size of (11.25 × 11.25) mm and a diameter of 1.50 mm as shown in Fig.1-b. The ultimate tensile strength of the steel mesh was 303 MPa based on laboratory testing of a single wire.

Glass fiber mesh, with uni-directional roving, was used with a nominal spacing of 4.2mm between roving. Each roving was 1.5 mm wide with a fiber area of 0.15 mm² in the main direction. The clear spacing between roving was 4.7 mm in the main and transverse direction as shown in Fig.1-c. The ultimate tensile strength of the glass fiber was 238.7 MPa based on testing an individual fiber.

A natural *Arundo donax*, more commonly known as wild cane, was obtained locally from Qaradagh district, Sulaimaniyah-Iraq. The average inner and outer diameter of the cane was 12.6mm and 17.2mm, respectively. The cane was cut, using a power saw, longitudinally into equal strips with an average width of 10mm. The strips were made into a grid with orthogonal directions putting the horizontal strips first and the vertical strips afterwards which were tied together using steel wire ties. The opening size of the grid was (40 × 40) mm as shown in Fig.1-d. The ultimate tensile strength of the cane was 94 MPa based on the "yüksel kaya makina" tensile testing machine at Seko laboratory, Sulaimaniyah.

The steel fibers were made from a woven steel wire mesh that was manually chopped using a metal cutter. The mesh was cut into smaller strips and then chopped into fibers as shown in Fig.1-e. The diameter of the steel fiber was 0.5 mm and the average aspect ratio was 50 depending on the chopped length. Due to the woven state of the mesh, the resulting steel fibers had a crimp-like shape. The ultimate tensile strength of the chopped steel fiber was 418 MPa based on laboratory testing of the wire before chopping.

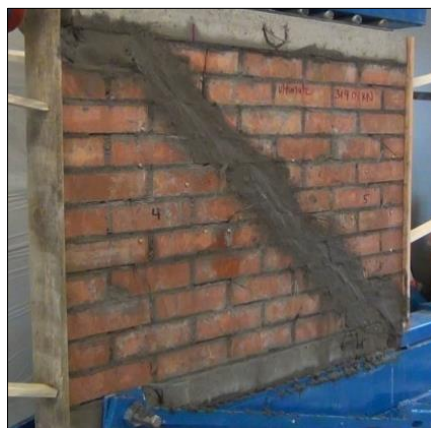
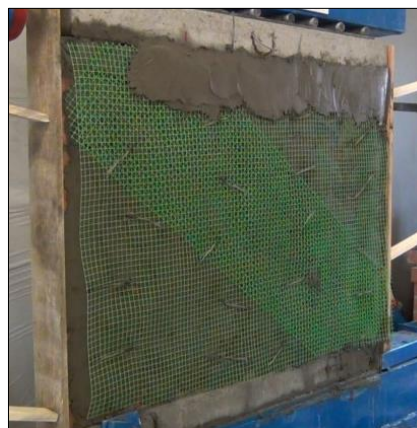
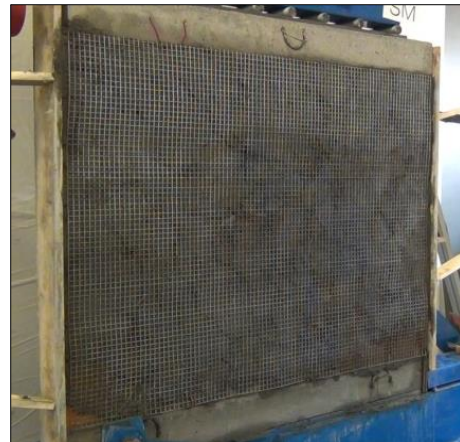
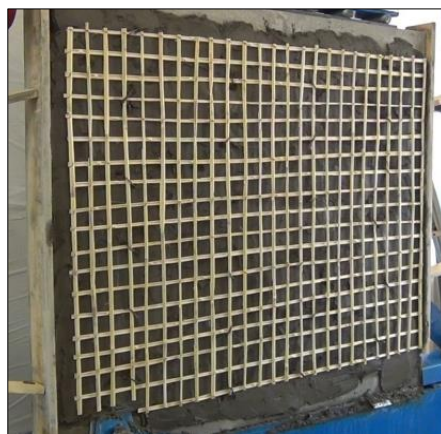
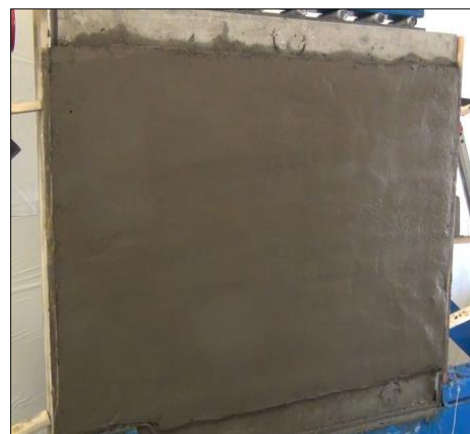
Fig.3: Strengthening procedure; (Source: Researcher)

(a) repairing initial damaged wall with 1:2 cement mortar.

(e) organic (wild cane) grid.

(f) steel fiber cement plaster.

Subsequent to the walls testing, all the damaged walls (except the control walls) were wetted and their cracks were repaired, as much as possible, with 1:2 (C: S) mortar using a trowel. For walls “PM” and “GM”, a thin layer of about 5mm was cement plastered and then a 40cm wide mesh was

placed first diagonally across the crack and later a second layer, covering the entire wall, was placed.

Both meshes (diagonal and full surface covering) were tied to the wall by the steel tie wires that were placed at specified locations (two at every horizontal joint) earlier during construction of the wall. A second layer of cement plastering, about 10mm, was applied covering the mesh and resulting in a total thickness of about 15mm cement plaster.

The same procedure was performed for wall “SM” except that only one mesh (covering the whole surface) was applied. For wall “OG”, one grid was applied and the total thickness was 20mm due to the thickness of the overlapping canes. Finally, for wall “SF”, a 10 mm cement plaster, mixed with 1.5% steel fiber (of total mortar volume), was applied. The strengthened walls are shown in Fig. 3.

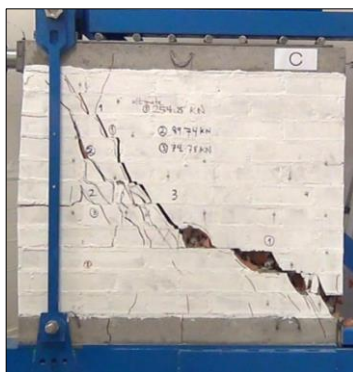
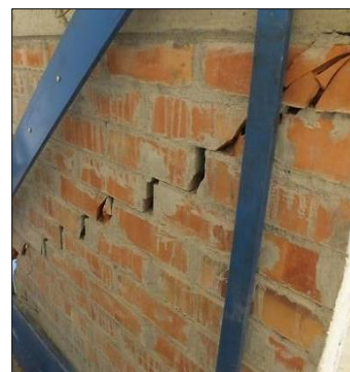
Fig 5: Failure mechanism of the control walls; (Source: Researcher)

(b) front side of cement plastered wall "PL"

(c) backside of cement plastered wall "PL".

Results of the tested specimens are shown in Table (4). The failure mode of the un-strengthened walls (C, PM, GM, SM, OG) was an explosive sudden shear failure at the peak load. The shear crack extended from the loading corner (left side) towards the compression corner (right side) and passed diagonally through both the brick and the mortar as shown in Fig.5-a.

aspect ratio of the wall. The failure pattern of “PL”, cement plastered wall, also exhibited a sudden shear failure, however, unlike the other walls, the path of the diagonal crack passed through the bed and head joints (stepwise manner) instead of the brick and mortar as shown in Figs. 5-b and 5-c.

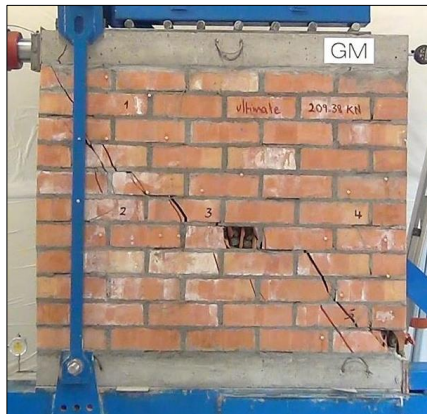
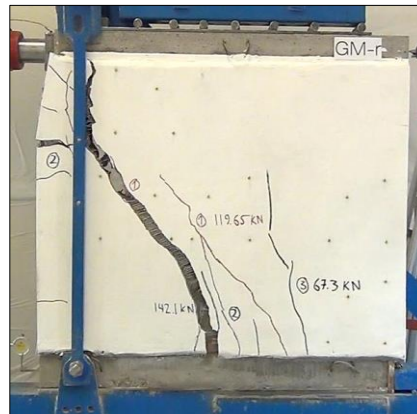
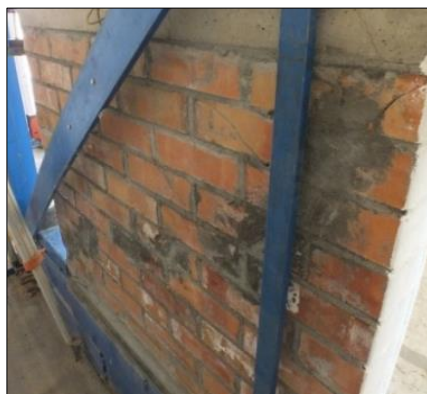
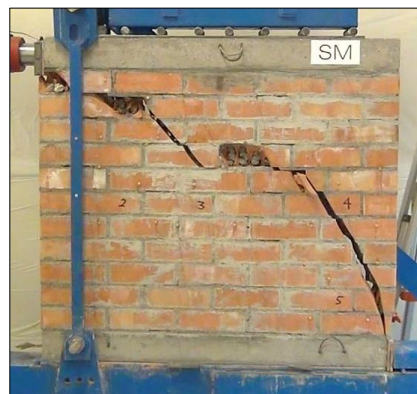
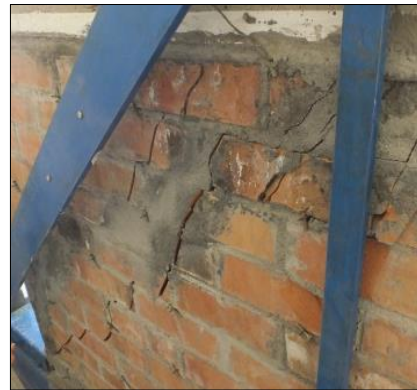
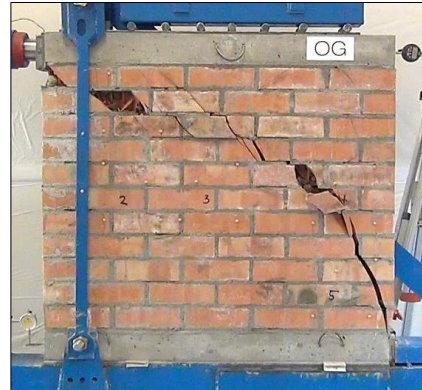
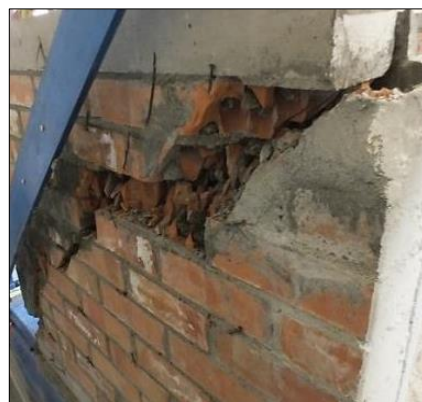
Fig.7: Failure mechanism of tested un-strengthened and strengthened walls; (Source: Researcher)

- (a) wall GM
- (b) wall GM-r.
- (c) plain side of GM-r .
- (d) wall SM (e) wall SM-r.
- (f) cement plaster de-bonding of wall SM-r.
- (g) plain side of SM-r .
- (h) wall OG.
- (i) wall OG-r.
- (j) plain side of wall OG-r.

There was a drop (37%) in load carrying capacity at the peak load and the diagonal cracks softly propagated towards the bottom of the wall but did not follow the same path as those of the original wall (GM). However, the plain side (backside) of the wall revealed that the cracks did in fact follow the original crack path (from GM) as shown in Fig.7-c. This is probably due to the plaster de-bonding at the right part of the wall. The continued load after the peak load caused gradual widening of the cracks, further gradual load drops, and rupture of the mesh fibers.

For wall “SM-r” (strengthened with steel mesh), numerous thin diagonal short cracks (energy dissipation) appeared at the peak load (254.24 kN or 89% of SM) as shown in Fig.7-e and when loading continued to be applied, the load did not increase but a loud sudden brittle de-bonding of the reinforced plaster (without yielding of the steel mesh) took place resulting in a huge drop (70%) in the load carrying capacity as shown in Fig.7-f.

The steel mesh caused a different diagonal path (as opposed to SM) on the wall as was revealed from the plain side as shown in Fig.7-g. The continued loading after failure only further separated the two diagonal parts of the wall behind the reinforced mesh.

When loading was continued, the existing cracks quickly propagated towards the compression corner, rupture of the strands was heard, and a larger drop of strength (30% from the 172kN) was observed. With further loading, four resulting major diagonal parallel cracks occurred from the loading corner towards the compression corner as shown in Fig.7-i.

wall failed through the original crack (from OG) as shown in Fig.7-j.

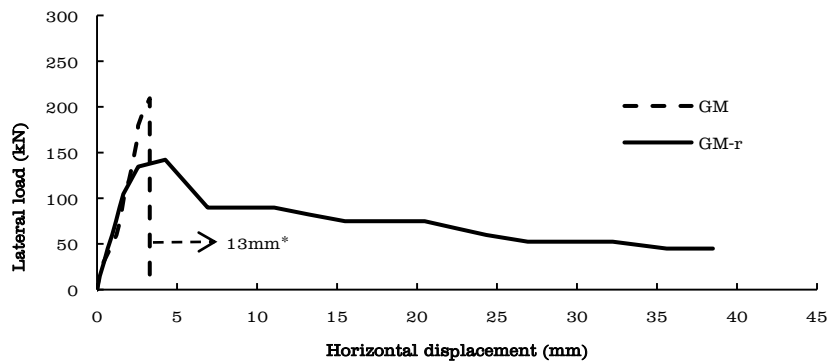
All the un-strengthened walls exhibited a fairly linear relationship up to the peak point (ultimate load) followed by an abrupt reduction in lateral load capacity with a sudden gain in horizontal displacement due to the explosive diagonal shear failure. The walls were brittle in nature and no residual strength or ductility was observed as shown in the dash lines of Fig.8-a to Fig.8-e.

The strengthened walls generally displayed similar load-lateral deflection behaviors. First, the slope of the graph showed an almost linear behavior until the peak point was reached, even when thin cracks were initiated in some of the walls.

The peak point is where the wall reached its ultimate loading capacity with little horizontal displacement. Then, the slope dropped rapidly, with noticeable change in strength and displacement, to a certain point based on the individual wall behavior. Afterwards, a steady decline was observed up to the end of the test as shown in Fig.8-a to Fig.8-d except for SF-r which could not sustain any further loading after the steep decline as shown in Fig.8-e.

very gradual and steady slope decline in their post peak behavior as shown in Fig.8-b and d. The other walls did not initiate cracks until the peak load was reached.

This is probably due to the absence of bolt anchorages (rather than the wire ties) to anchor the mesh with the wall. Wall PM-r showed the least strength recovery (43%) out of all the walls but was able to add some ductility to the wall unlike SF-r which had a slightly higher strength recovery (47%) but did not change the brittle type failure and the post peak behavior of its original wall (SF) as shown in Fig.(8-a and e).
