Evaluation of water atomized solid-state laser apparatus as a method for debonding ceramic orthodontic brackets (An In vitro study)

Dr. Omar Fawzi Abduljabbar Chawshli, BDS, MSc, PhD.*

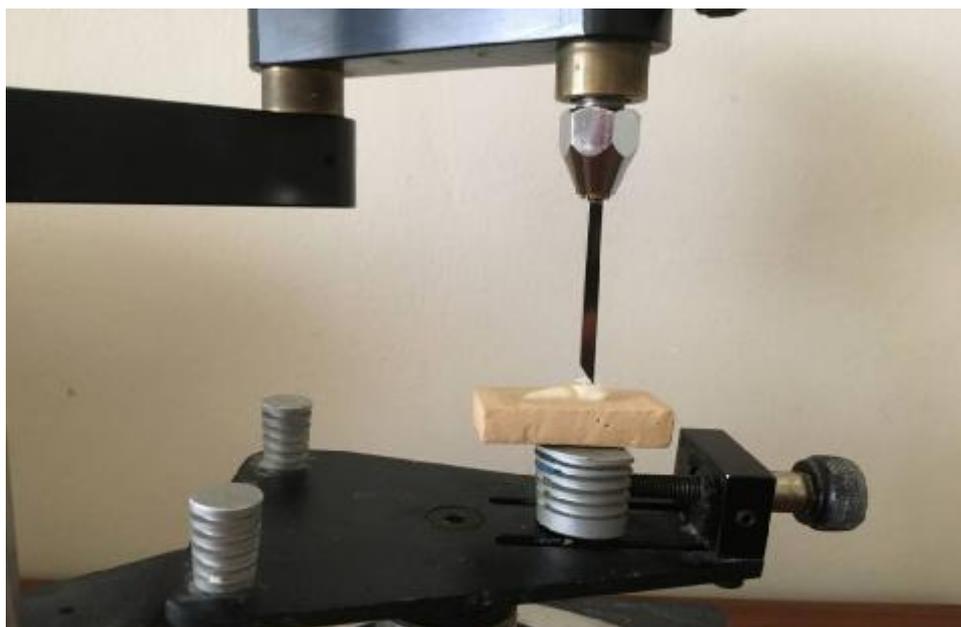
Figure (1) Bracket bonding procedure with the help of a surveyor for applying a constant force

Ceramic orthodontic brackets (Roth, 0.22) 40 mono-crystalline brackets (PURE, Ortho Technology, USA) for the 1st group and 40 Polycrystalline ceramic brackets (Reflections, Ortho Technology, USA) for the 2nd group were bonded to the buccal surface of all teeth with Transbond XT (3M Unitek, USA) adhesive; applying a constant force with the help of a surveyor as shown in figure (1), excess composite was gently removed before curing and light cured with light unite.

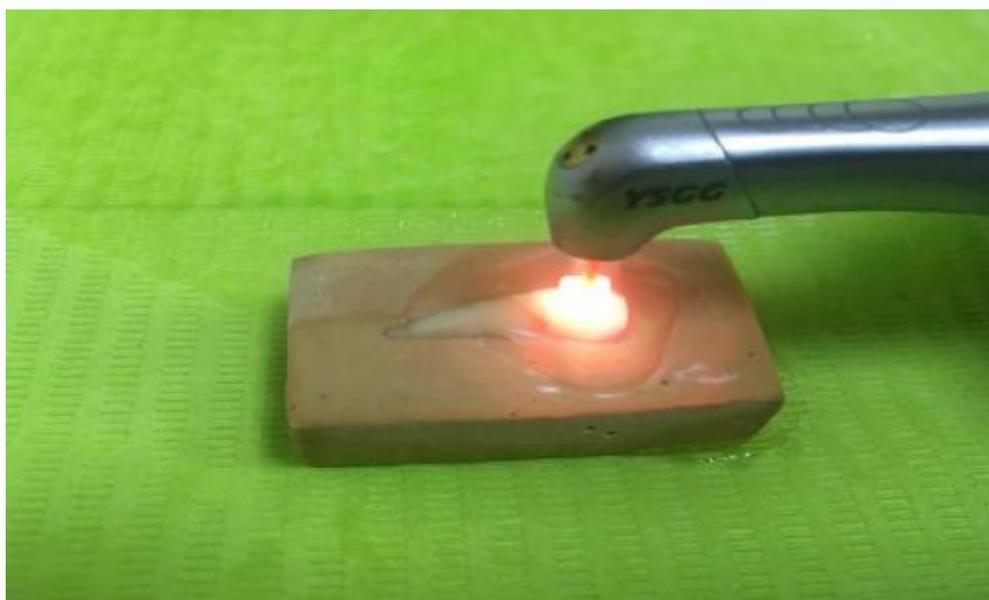
Figure (2) bracket debonding using water atomized laser

Each of the main groups of the sample is subdivided into two equal groups, (group-a) 20 teeth debonded with water-atomized laser and (group-b) 20 teeth debonded manually with utility pliers. Debonding of the all group-a brackets from both main groups done at the same time using the biolase water laser system (YSGG solid-state laser with water atomization) (I Plus, BIOLASE, USA) by applying the laser head for hard tissue cutting directly to the ceramic bracket which debonded like a popping manner from the tooth as shown in figure (2). Debonding of all group-b brackets from both main groups done at the same time using Utility pliers (Dentaurum, Germany) according to manufactures direction, and then all the
