STRENGTHENING OF CRACKED REINFORCED CONCRETE T-BEAM BY JACKETING

Dr. ADNAN SADIQ AL-KUAITY
Lecturer Of Civil Engineering,
Engineering Faculty, University of Kufa

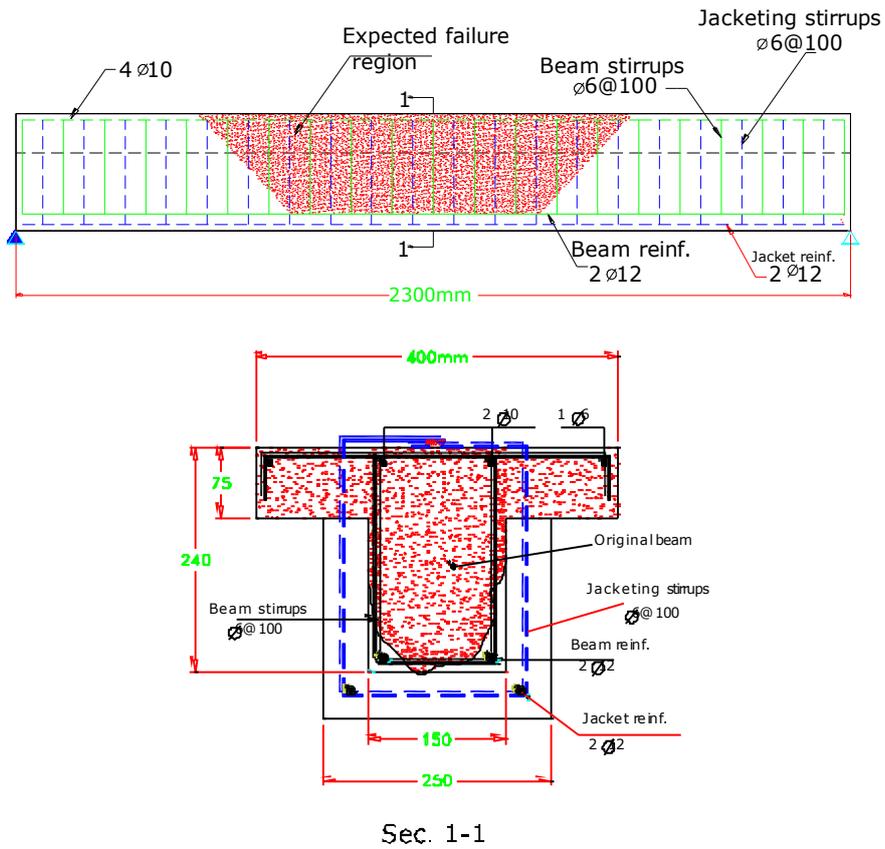
Figure (1) Typical jacking of test beams

Series BO beams is designed to investigate the effect of preloading ($\lambda=0\%$, 60%, 77% and 100%) on the strength and behaviour of beams (B0, B60, B77, B100) after repair. Beam B100 is loaded first to failure, then repaired by jacketing method (see Figure (1)) and tested again up to failure. This beam was designed to study the possibility of restoring the flexural capacity by using jacketing method. Beam B0 was not loaded at first stage and therefore has no cracks whereas the other (B60, B77) were loaded at first stage up to 60% and 77% of failure load which produced flexural hair cracks at first stage. All beams have same flexural capacity. Then, all these beams were strengthening by jacketing as shown Figure(1) and Figure(2).

The main tensile reinforcement (bottom reinforcement) is kept constant ($2\phi 12$). Minimum stirrups of $\phi 6@100\text{mm cc}$ was used in the original beams and same amount was used again at jacketing to prevent shear failure. The new stirrups added to the beams during repair are welded from the top by overlapping the bar's end at a distance 4 times diameter of bars [BS, 1990]. The original beams (B60, B77, B100) were loaded first up to the degree of loading λ mentioned above (60%, 77%, 100%), then, they were repaired as shown in Figure(1) and (2). Then, all beams retested again up to failure.

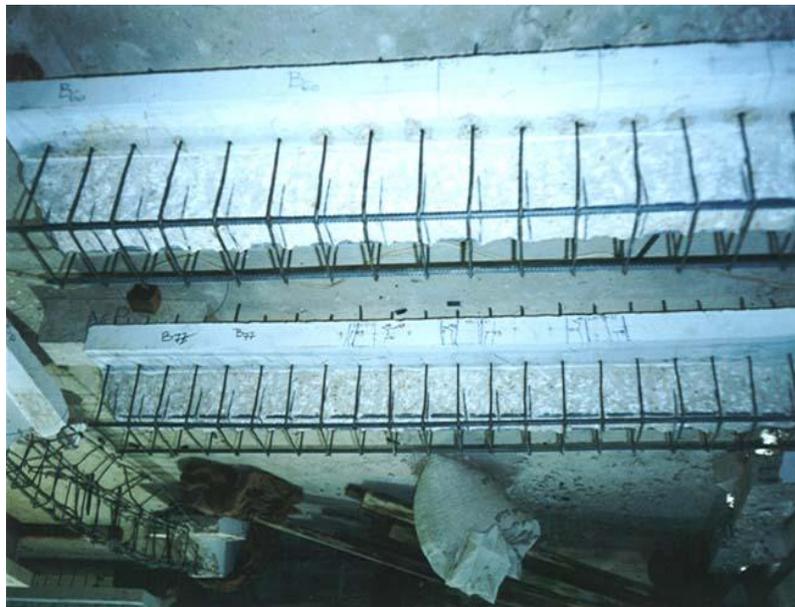
Figure (2) Preparing of beams B60 B77 B100 for jacking

- Remove all the concrete which has been cracked or crushed at compression zone and else where due to failure of beams (B100)
- Remove the concrete covers of the sides and bottom reinforcement for beams (B0, B60, B77), which are prepared for strengthening.
- Clean concrete surface by washing with water for all beams.
- Fix the new main steel reinforcement for beam (B0, B60, B77, B100) as shown in Figure (1) and (2).
- Prepare concrete mix in same quantities of materials used for the original beams.
- Before casting the new concrete, all concrete surface should be covered with 1:1 water : cement liquid.
- Concrete was compacted by using damping rod and vibrators.
- Beams were cured again for 28 day before testing.

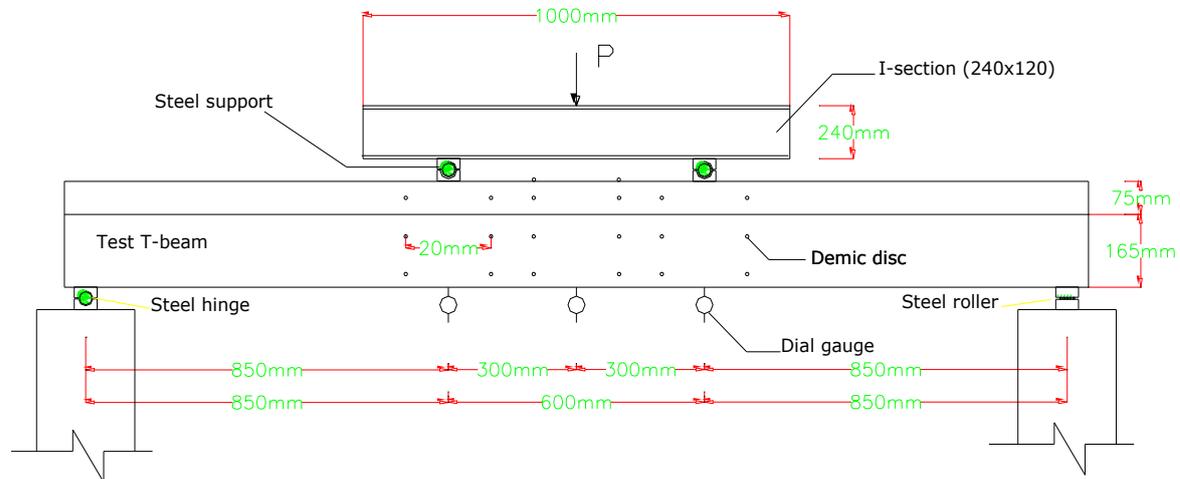
Figure (3) Typical instrumentation of test beams

- The sample was put under the test instrument type FM 2750 machine Nr. 613 wolpert ch-8232 Merishausen where the hydraulic jack is used to exert load on the specimen
- (See Figure (3).
- The load capacity of the testing machine used is 30 tons and its sensitivity is 0.1 KN
- The specimen was put on supported roller to be simply supported.
- A steel beam with a dimension of 1000 x 240 x 120 mm was used to transfer the single load from the testing machine to two points loads on the tests specimen. The said steel beam would change the concentrated loads in to two equal loads.
- The initial readings were taken before loading, for all deflection points and concrete strain gauges.

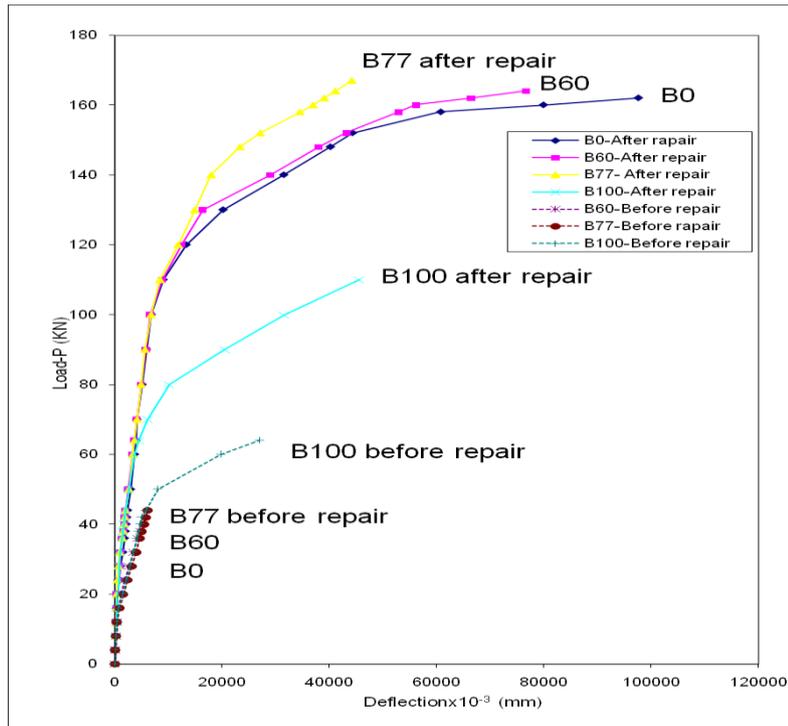
The deflections along the spans of the test beam before and after repair were measured at all stages of loading. The maximum centre deflections for these beams were plotted in Figure (4). as a function of the total applied load. All beams have shown similar behavior before and after repair. These curves are composed of three distinguished regions namely, pre-cracking stage, post cracking stage and post serviceability cracking stage.

Figure (4) Load-deflection curves of beams before and after jacketing

When the load on the test beams is gradually increased beyond the first crack to the service load, the behaviour of beams changed slightly in to a post-cracking stage. Figure (4) showed that the relationship between load and deflection at post-cracking stage are approximately linear defining semi-elastic behaviour.

However, Fig (4) shows that the beams repaired by jacketing gave higher flexural stiffness than their original flexural stiffness, in spite, of the existing cracks in the original concrete. This means the jacketing is significantly increased the flexural stiffness and hence would improve the serviceability.

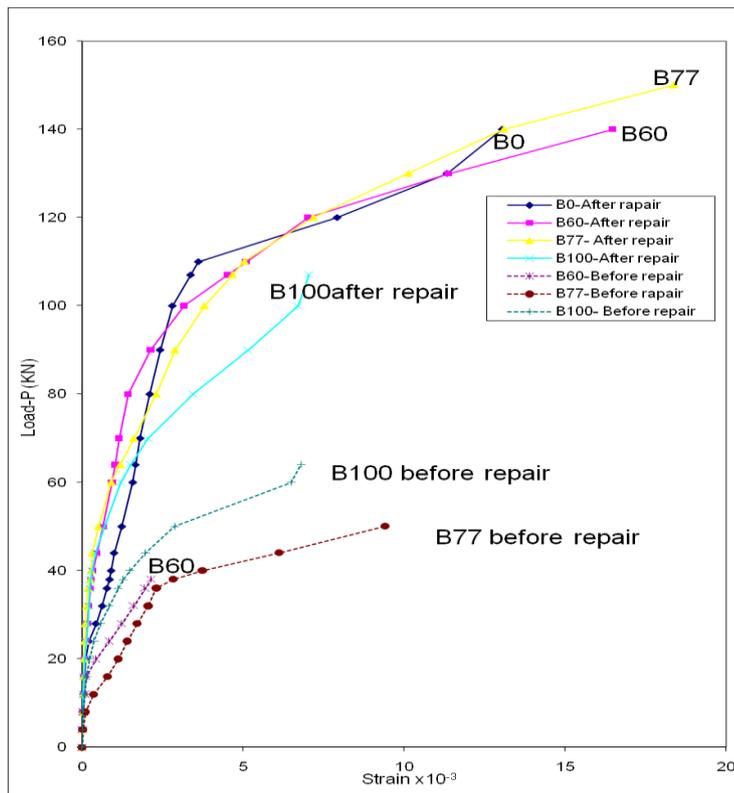
The load-tensile steel strain curves at mid-span were plotted for all beams before and after repair as shown in Figure (5). Three different stages of behaviour can be clearly distinguished.

Figure (5) Load-steel stain curves for beams before and after repair by jacketing

Test results show that the repair by jacketing causes a great decrease in the tensile strain of the original beams. This means that the reinforcement of the jacketing is significantly contributing in resisting the applied load besides the original reinforcement. The percentage of decrease is ranging between about 90% in beam B77 to about 70% in beam B100 at service load.

On the other hand, the top steel plate reduced the steel strain in beams before repairs as shown in Fig. (5).

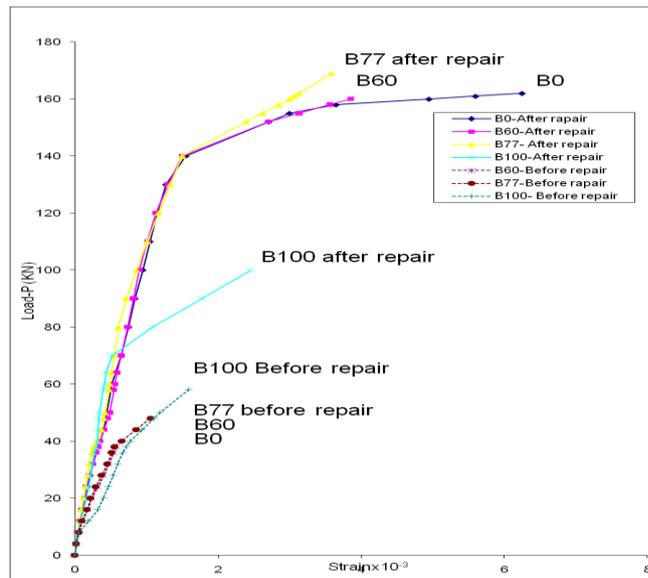
Figure (6) Load-compressive strain curves for beams before and after repair by jacketing

Concrete compressive strains at top fibre of the mid-span section of each beam were measured. Compressive strains under the point loads are also measured. The compressive strains at the mid-span are plotted with applied load for all test beams as shown in Figure(6). The load compressive strain behaviours are similar to the load-tensile strain behaviour discussed elsewhere. Therefore, there is a consistency between the tensile and compressive strain under loading. This should be existing to agree with the rational theory of ultimate bending strength of the beam (strain distribution across any section of the beam is assumed to be linear).

Reinforced jacket acted to redistribute the compressive strain between the original and new concrete. Therefore, the compressive strains are reduced in compression zone of repaired concrete compared to the original strains as shown in Figure (6). The percentage of reduction was observed to be between about 30% in beam B60, Fig. (5.35) to 60% in B100 Fig. (5.39). This behaviour is consistent with the original behaviour . All repaired beams have reached to the specified yield strain of concrete or slightly higher than that. The observed yield strain was ranging between about 0.0035 to 0.0060. The concrete strain in the original beam has reached to about 0.003. This indicates that the jacketing increased the ductility of concrete.

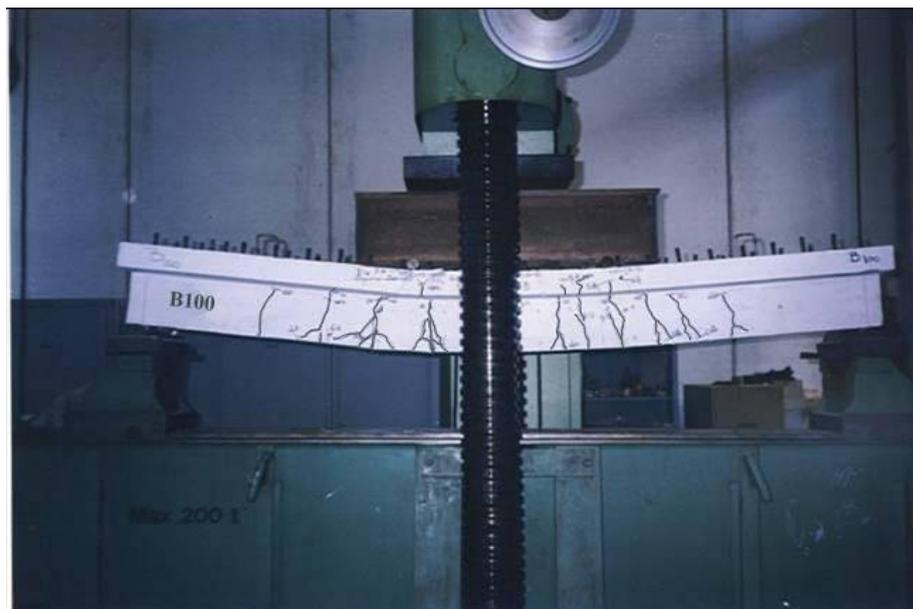
Figure (7) Cracking of Beam B100 (before repair)

The initial flexural cracks have first developed in all beams tested except beams B0, which was not loaded before repair. The typical cracking condition of B100 is shown in Figure (7). All beams have shown that the first crackform at about same load, which was about 16 KN because these beams were identical. The flexural cracks developed at bottom fibre in the region of maximum bending moment (between points loads). These cracks penetrated upward as the load increased and new cracks spread toward the points load. Then, the load was removed when it reached to 60% of the ultimate load (B60) whereas the applied load continued, untill 77% of the ultimate load in beam B77 . In this beam, the flexural cracks penetrate deeper in the flange of the beam (compression zone) and some cracks separated

As the loaded increases above 77% of the ultimate load in beam B100, the cracks, under the left point load have deeply penetrated to the compression zone resulting in complete failure by crushing the flange under the point load resulting a complete flexural failure.

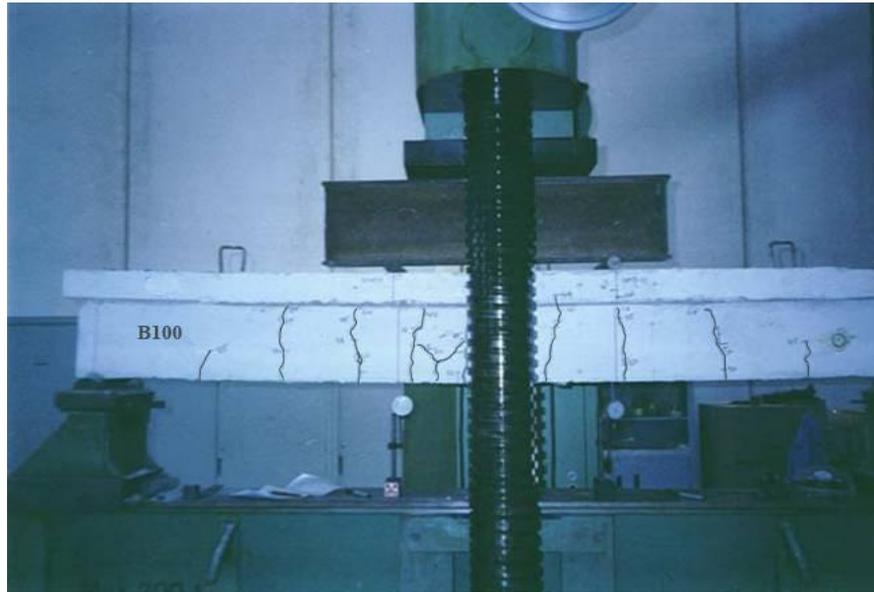
Figure (8) Cracking of Beam B100 (after repair)

After repairing beams B60, B77, B100 by jacketing, the cracking behaviour were approximately similar to those observed before repair . A typical cracking condition of beam after repair is shown in Figure(8). Then, the mode of failure of beam B100 after repair Figure (10) was exactly in similar type and in same location as that of the original beam before repair Figure (9). Beams B60, B77 showed similar mode of failure after repair as in beam B100 but with improved ductility (large deflection before failure). This indicates that the behaviour of strengthened beams (B77, B60) are more ductile than the retrofitted beam (B100).

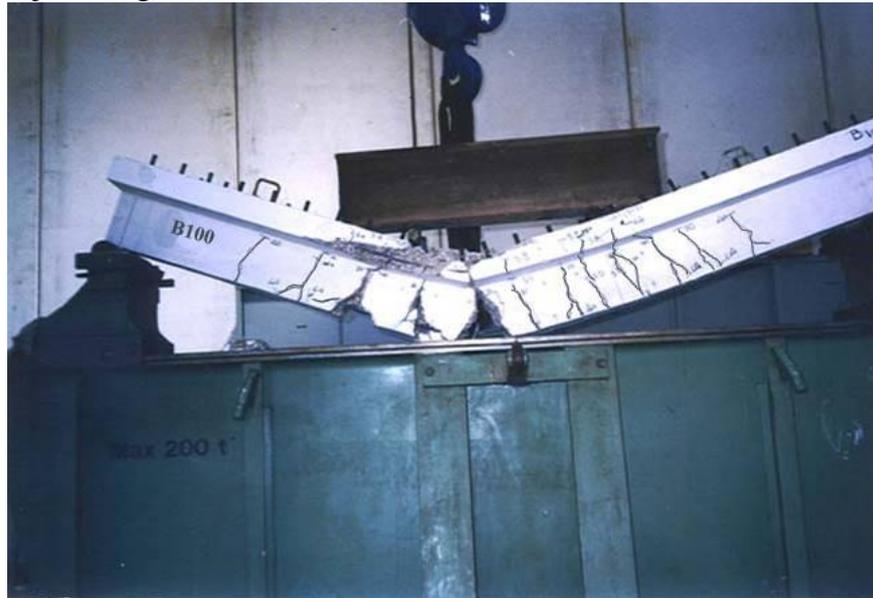
Figure (9) Flexural failure mode of Beam B100 (before repair)

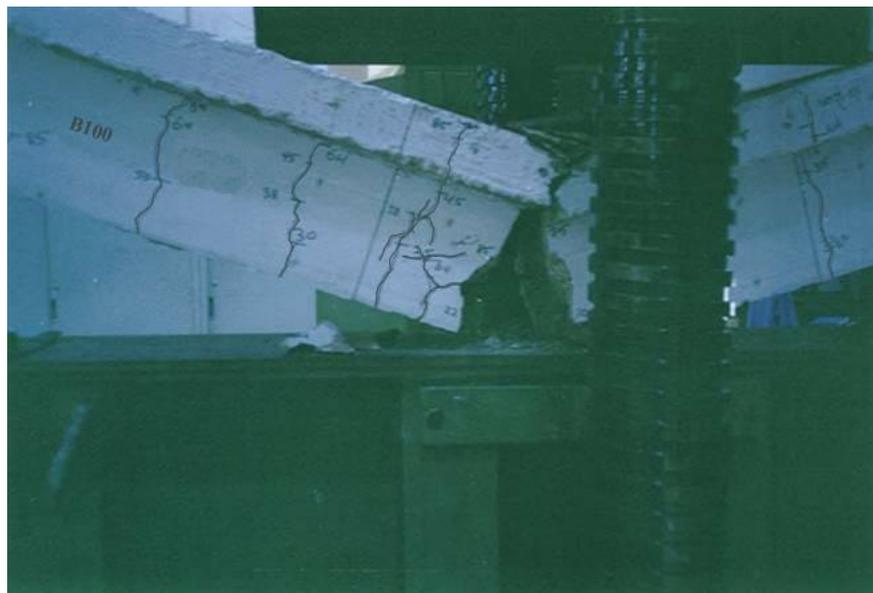
Figure (10) Failure mode of Beam B100 (after repair)

For beam B100, the jacketing was restored about 167% of the original ultimate capacity of the beam. The original reinforcement in this beam was useless since it was ruptured by the first test before jacketing. The ratio between the theoretical and the experimental failure load was about 0.73. This means that the existing ruptured steel contributes in resisting applied load. However, the yield reinforcement may carry about 27% of the failure load in the second test (after jacketing).

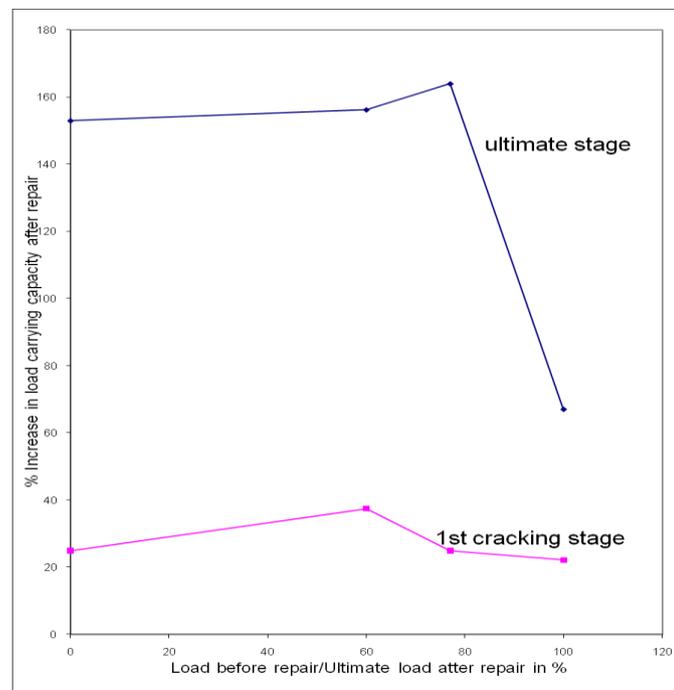
, which corresponded to crack condition of the original beams before repair as shown in Figure (11). All beams have same failure load because they are identical. The conditions of cracks at the original beams were marked on the axis.

Fig. (11) Effect of loadig before repair on the strength of beams repaired by jacketing

Figure (11) shows that, the existing flexural cracks in the original beam up to load level of 77% has no significant effect on the strength after jacketing. The strength of beams after jacketing is mainly affected by the amount both the existing reinforcement and the reinforcement of jacketing. The reduction in the strength of beam failed in flexural before jacketing, (Beam B100) compared to other, (B0, B60 and B77), was mainly due to lost of original reinforcement by rupture during the first test.
