Surface changes of orthodontic brackets following treatment with fixed orthodontic appliances

ABSTRACT

Materials and method: 150 orthodontic brackets related to three different companies (Orthodont, Ortho-organizers, and Dentaurum). These brackets examined after removing them from the patients' mouth and examined microscopically.

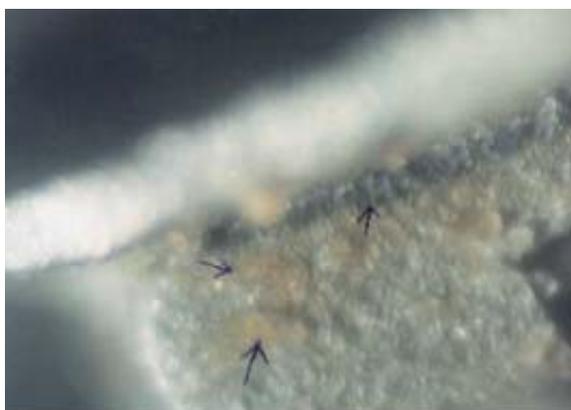
Fig.(5): Corrosion at the inner side of the wing and between the wing

The result of microscopical examination indicates that the most stagnation areas in the bracket were the slot of the bracket, region of the bracket bounded between the inner side of the wings and the base of the bracket, and the borders of the bracket base. food debris and rust manly accumulated at these regions. Fig.2 debonding the resin and cleaning the brackets and re-examination of the same examined bracket reveals that the stagnation areas were more affected by corrosion attack than the other sites. Pitting corrosion can be seen simply on the outer surface of the wings of the brackets (Fig.3) areas of the an extensive pitting and crevice corrosion can be seen obviously at the slot of the bracket (Fig.4), inner side of the wing, the areas bounded by the wing and the base of the bracket (Fig. 5), and at the borders of the base of the bracket (Fig.6) Green, brown, and black precipitate can be seen at the mesh of the bracket (Fig.7,8)

The stagnation areas were affected by extensive pitting and crevice corrosion is mainly due to differential aeration in these areas (slot, inner side of the wing, and the area between the wing and the base). Oxygen depletion will take place because of the accumulation of debris and the presence of microorganism which cause obstruction on the surface, so no further oxygen reduction occurs and more dissolution of the metal in these areas and production of positive charges which balanced by the migration of chloride ion to the shielded areas and oxygen reduction on the adjacent areas so that the neighboring areas were protected while the shielded areas enlarged (Fig.10). Additionally the slot of the bracket subjected to wires with different alloys which differ in potential than the stainless steel of the bracket and this lead to electrical cell with more corrosion and destruction to the less potential alloy.

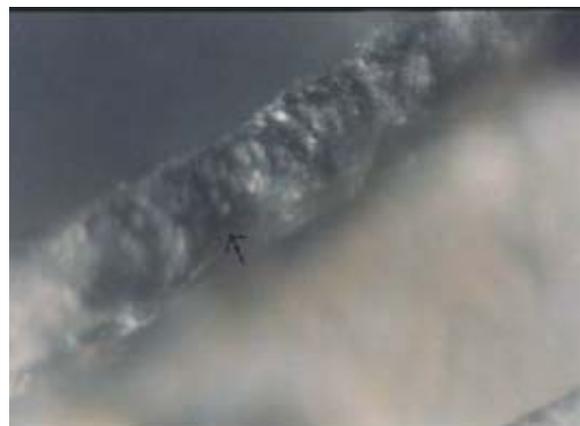
Fig.(6): Corrosion at the borders of base of the bracket

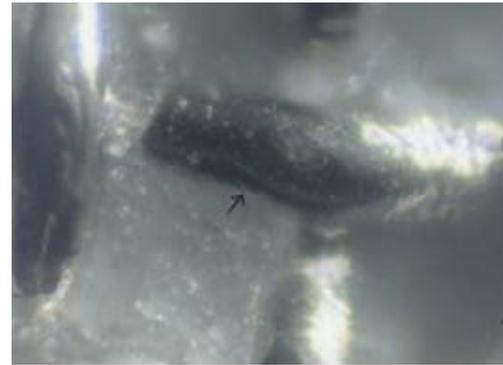
Fig. (8): Black precipitate at the mesh of the bracket

The corrosion at the mesh was mainly due to cracks in the bonding at the mesh side which lead to stagnation areas and crevice corrosion brown and black precipitate represent ferrous and ferric oxide which are punched out due to the destruction of chromium oxide layer and difficulty of its re – establishment since the area is extremely not aerated compared to the rest of the bracket facing the oral cavity leading to small anode (mesh of the bracket) and large cathode (the rest of the bracket) so huge destruction in this area. The green precipitate represents nickel oxide which is pushed to the surface due to the presence of corroded areas and destruction of chromium oxide (Fig.11).
