# Removal of mercury contamination from the dental clinic with metal backing for X-ray film

**Background:** Mercury in dental clinic has been recognized as a potential health hazard. This evaluated the removal of Hg spills from different surface in dental clinic with tin in the metal backing for dental x-ray film.

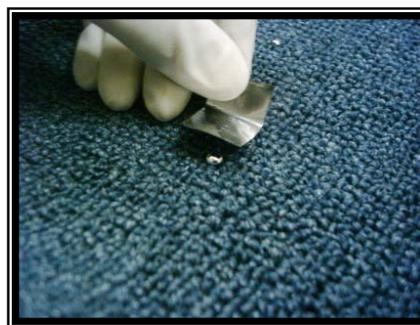
**Figure 1: Application of metal backing for x-ray film on Hg spill placed on the superficial surface of the carpet**

The interaction of mercury and tin in the metal backing for x-ray film was studied by using 45 sheets of metal backing for dental x-ray film, each one (0.8 g) divided into two pieces, each piece (0.4 g) was bent (in 45° bend) to facilitate its application and removal, then it was held in one hand (Figure 1) while a digital timer was held in the other hand. The time interval between the application of tin and adsorption of mercury was recorded in seconds. (Figure 2)

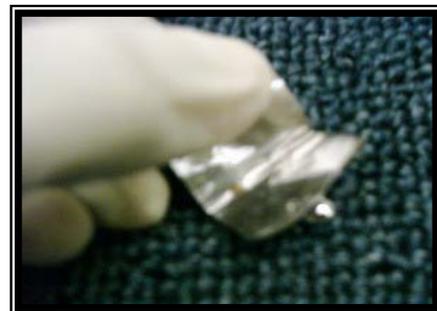
**Figure 2: Adsorption of Hg spill to the metal backing for x-ray film.**
