Relevant Problems of a Hydraulic Jump at Diyala Weir and the Proposed Remedy

Dr. Jaafar S. Maatooq

Building and Construction Engineering Department, University of Technology/Baghdad

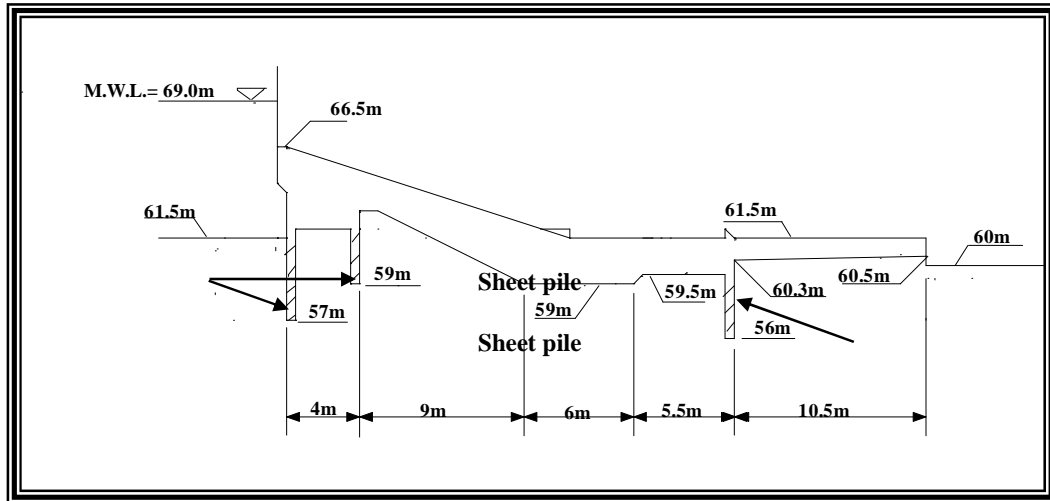
Figure(1) Dimensions of Diyala Weir Structure (modified from report of Consulting Engineering Bureau / Baghdad. Univ. 2005).

h) **Elevations:** The Weir crest el. 66.50 .a.s.l , the Scour sluice invert el. 61.50 a.s.l , the Canal head regulator invert el. 64.00 a.s.l ,Figure(1), illustrates the dimensions of Diyala weir structure with its sheet piles.

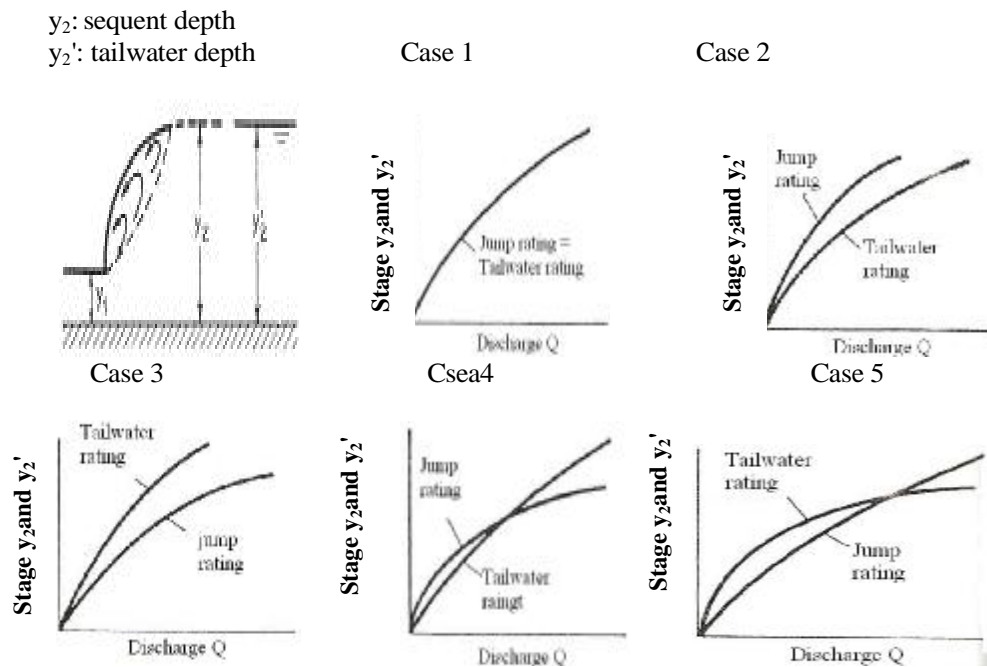
Figure 2: Classification of tailwater conditions for the design of scour-protection works (After Chow, 1959)

It is assumed that the tail water has a certain fixed position, whether its depth y_2' is equal to, less than, or greater than the sequent depth y_2 . In most practical problems, however, the tail water fluctuates, owing to changes in discharge of flow in the channel. In such cases, a tail water rating curve is usually available to show the relation between the tail water stage , y_2' , and the discharge Q . in a similar way, a jump rating curve may be constructed to show the relation between the sequent depth , y_2 , and the discharge Q . Because of the difference in the relative positions of the two rating curves, (Leliavsky, 1965) has suggested that the design may be considered according to five different classes of conditions as shown in Figure (2) .
